Historic Digital Survey

Digital Data Acquisition and Processing
for Historic Building Fabric Condition Survey and Interpretation

Enrique Valero, Alan Forster, Frédéric Bosché

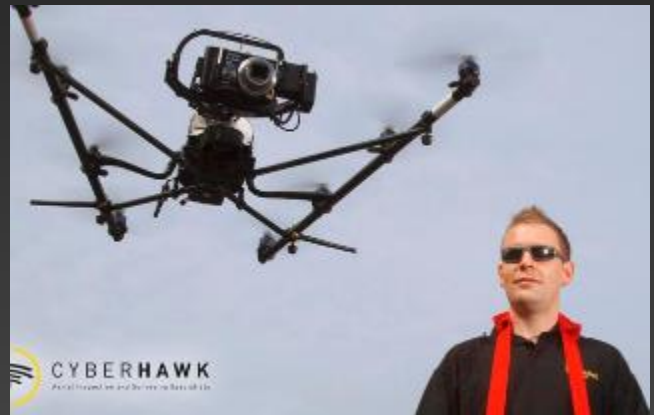
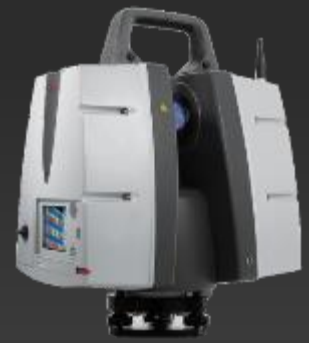
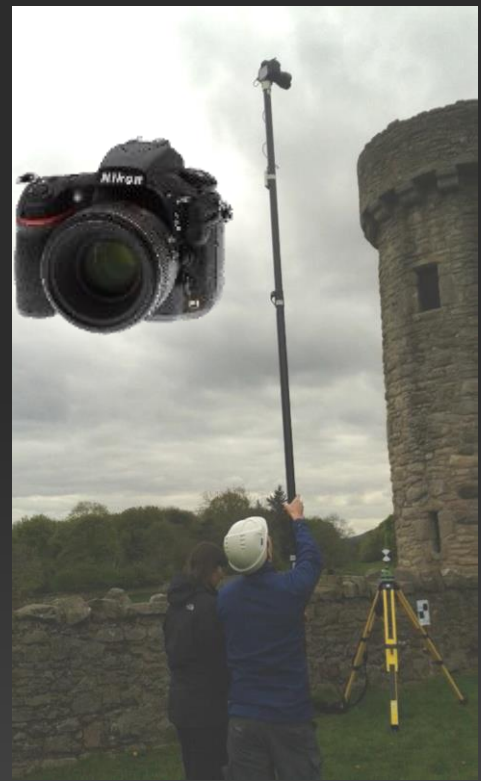
Technologies

- Terrestrial Laser Scanning
- DSLR Cameras (UAV and pole-mounted)

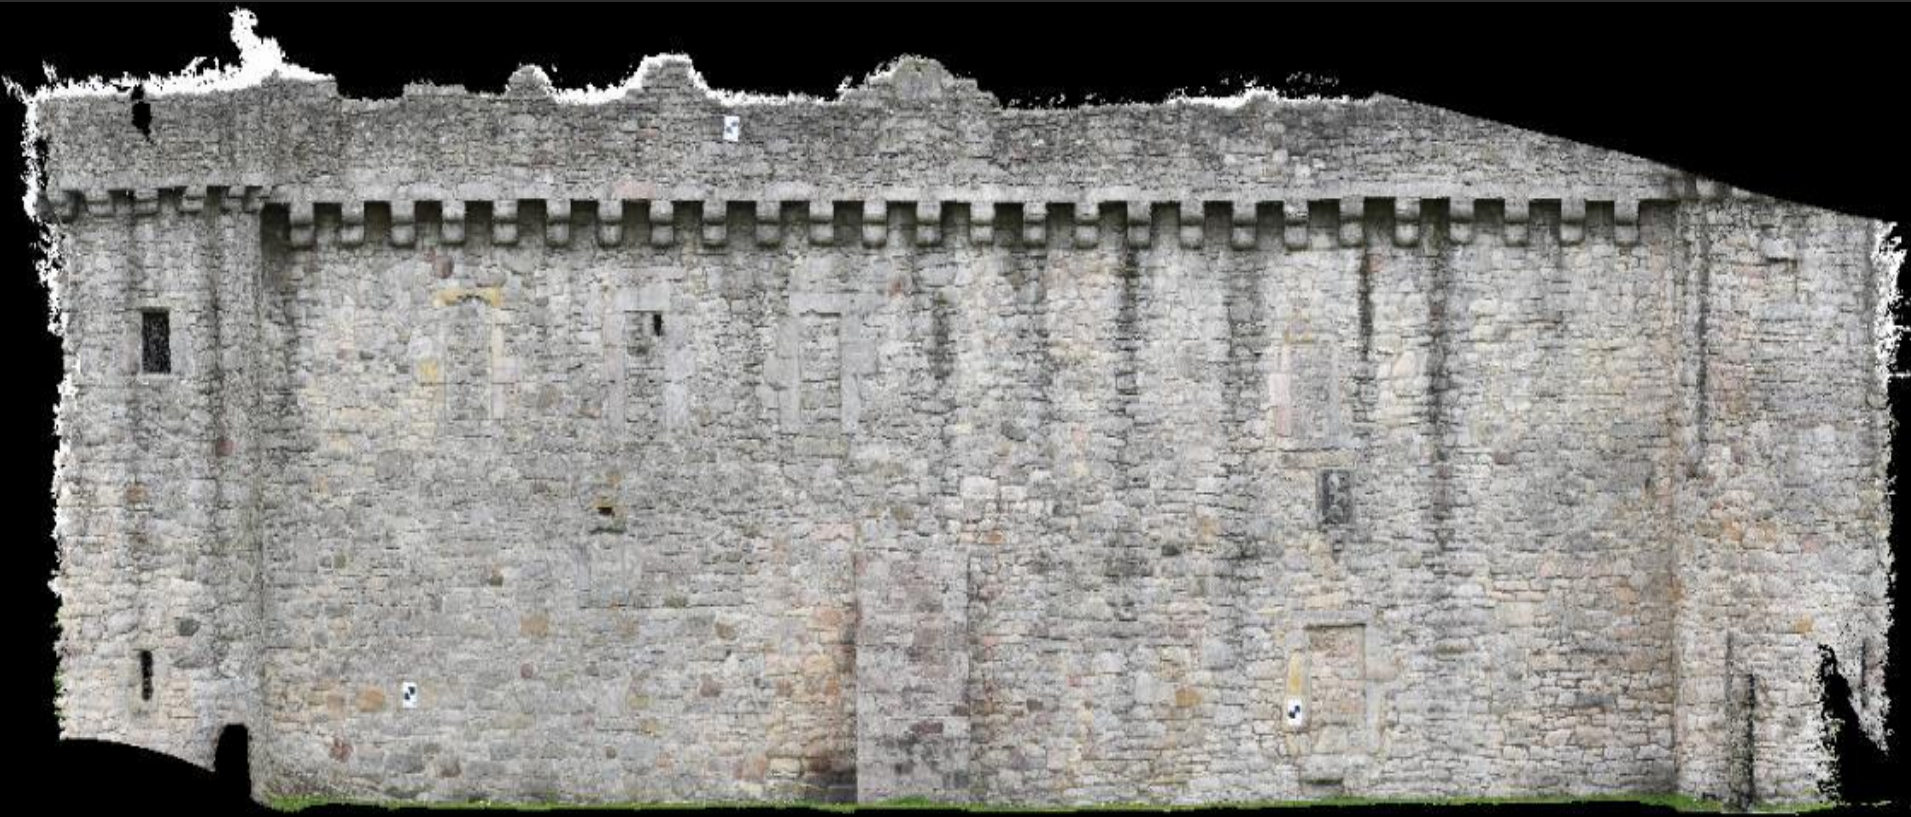
Craigmillar Castle

Reality Capture

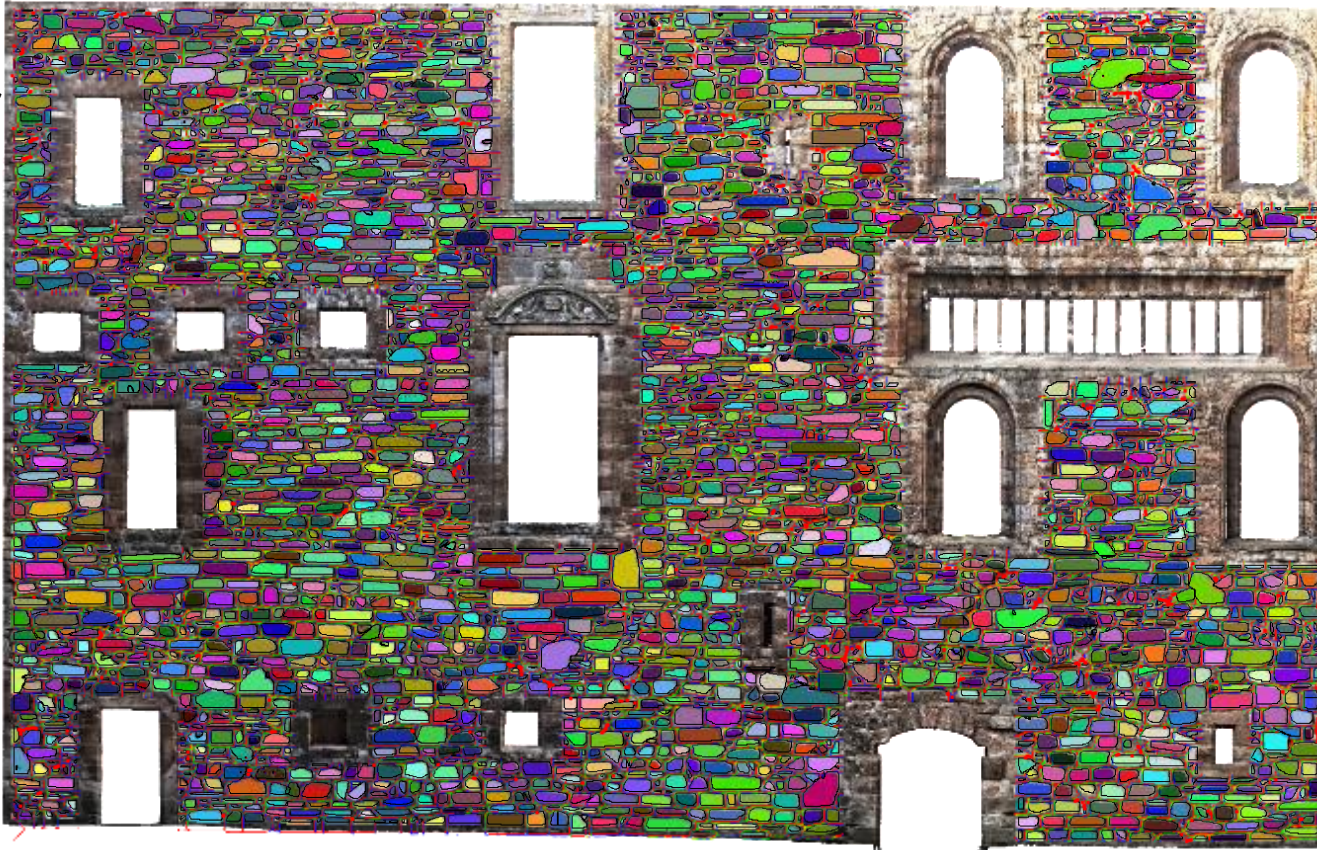
Linlithgow Palace

Rubble

3,100 stones
1,44 km mortar

- Data Processing: Segmentation of rubble & ashlar stonework
- Bespoke algorithms developed for both types of masonry
- Extract value from point cloud data
 - Labelling - identification
 - Quantities
 - Defects

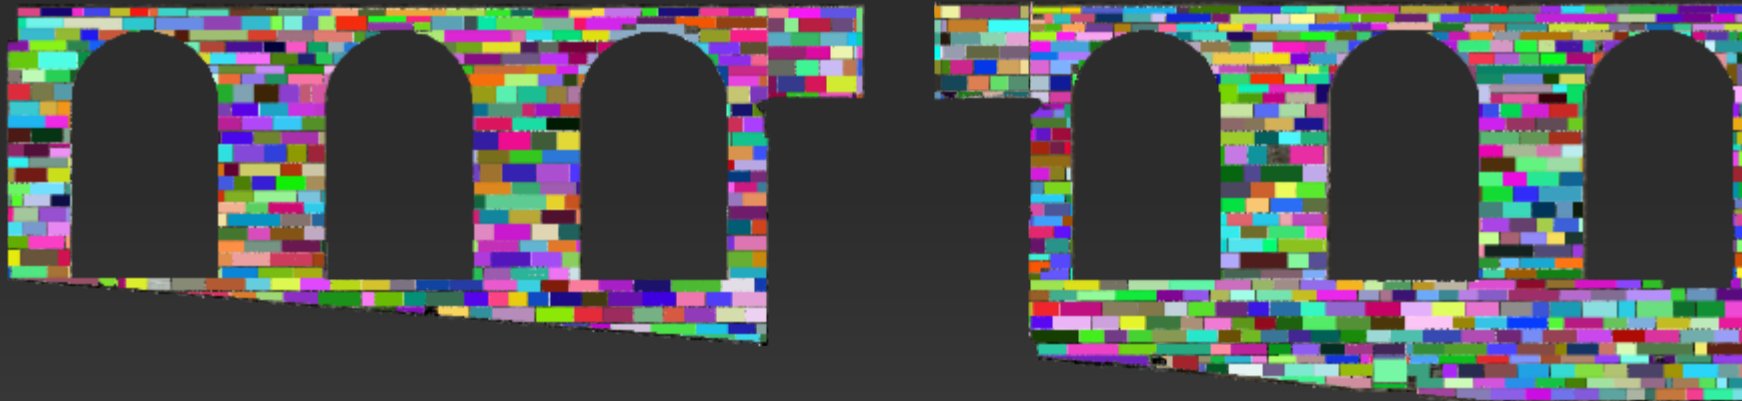
Chapel Royal, Stirling Castle

Ashlar

763 ashlar units

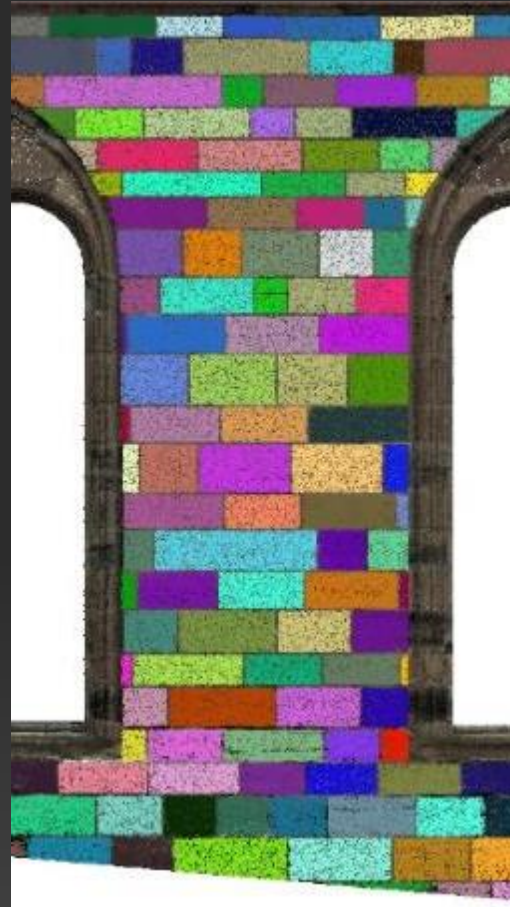
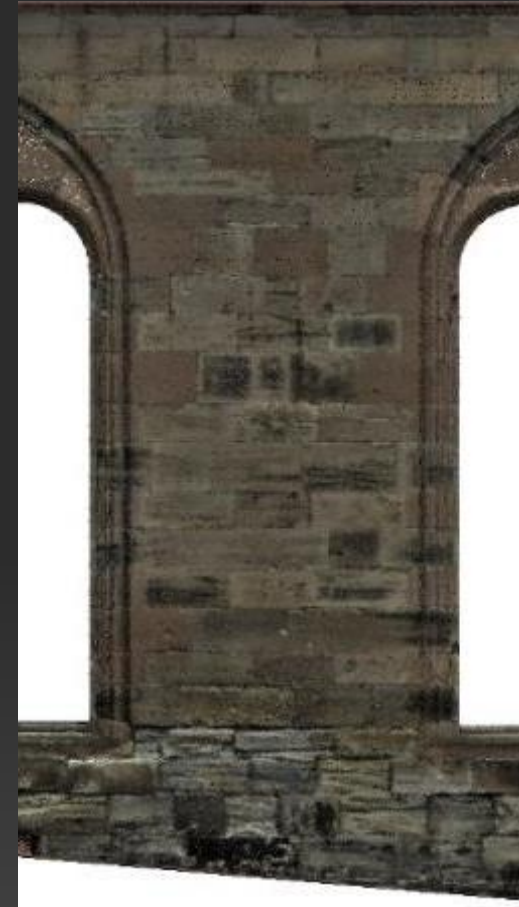
■ Ashlar

- Accurate sizes for dimensional stone
- 2D CWT using both 3D + Colour

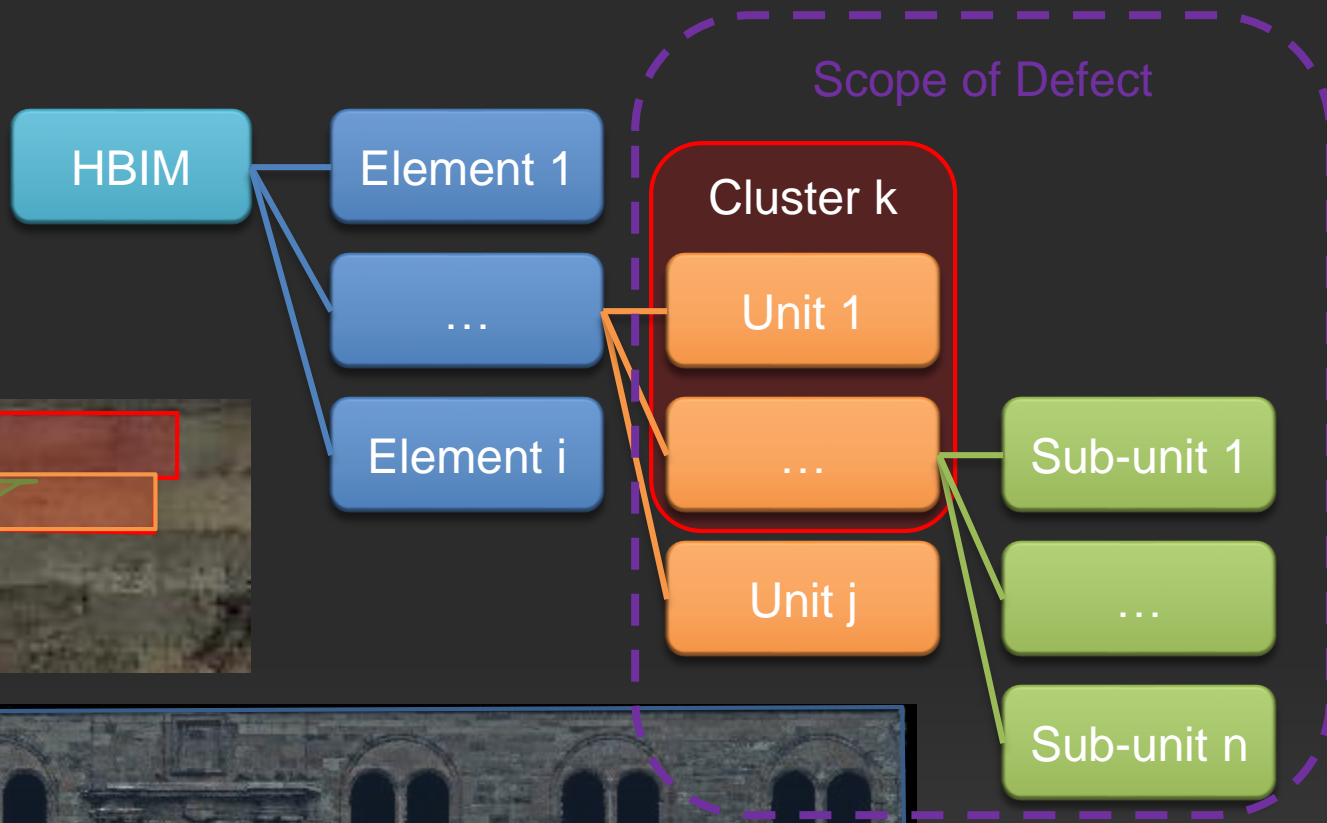
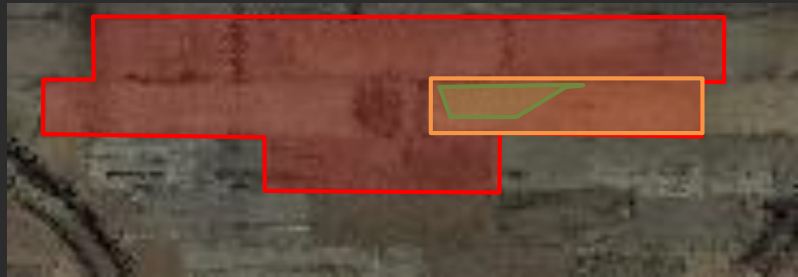
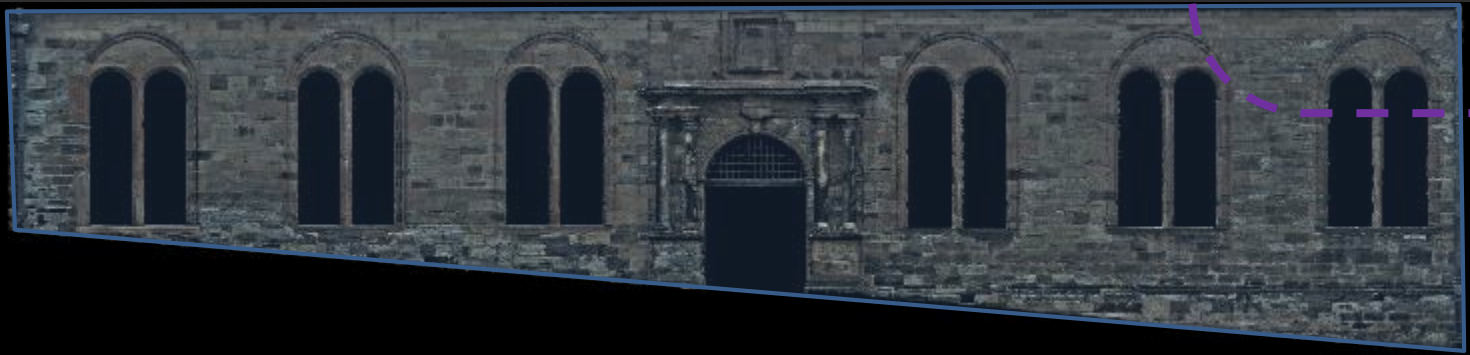
- Masonry wall surveying requires identification of its sub-components, i.e. stones and mortar

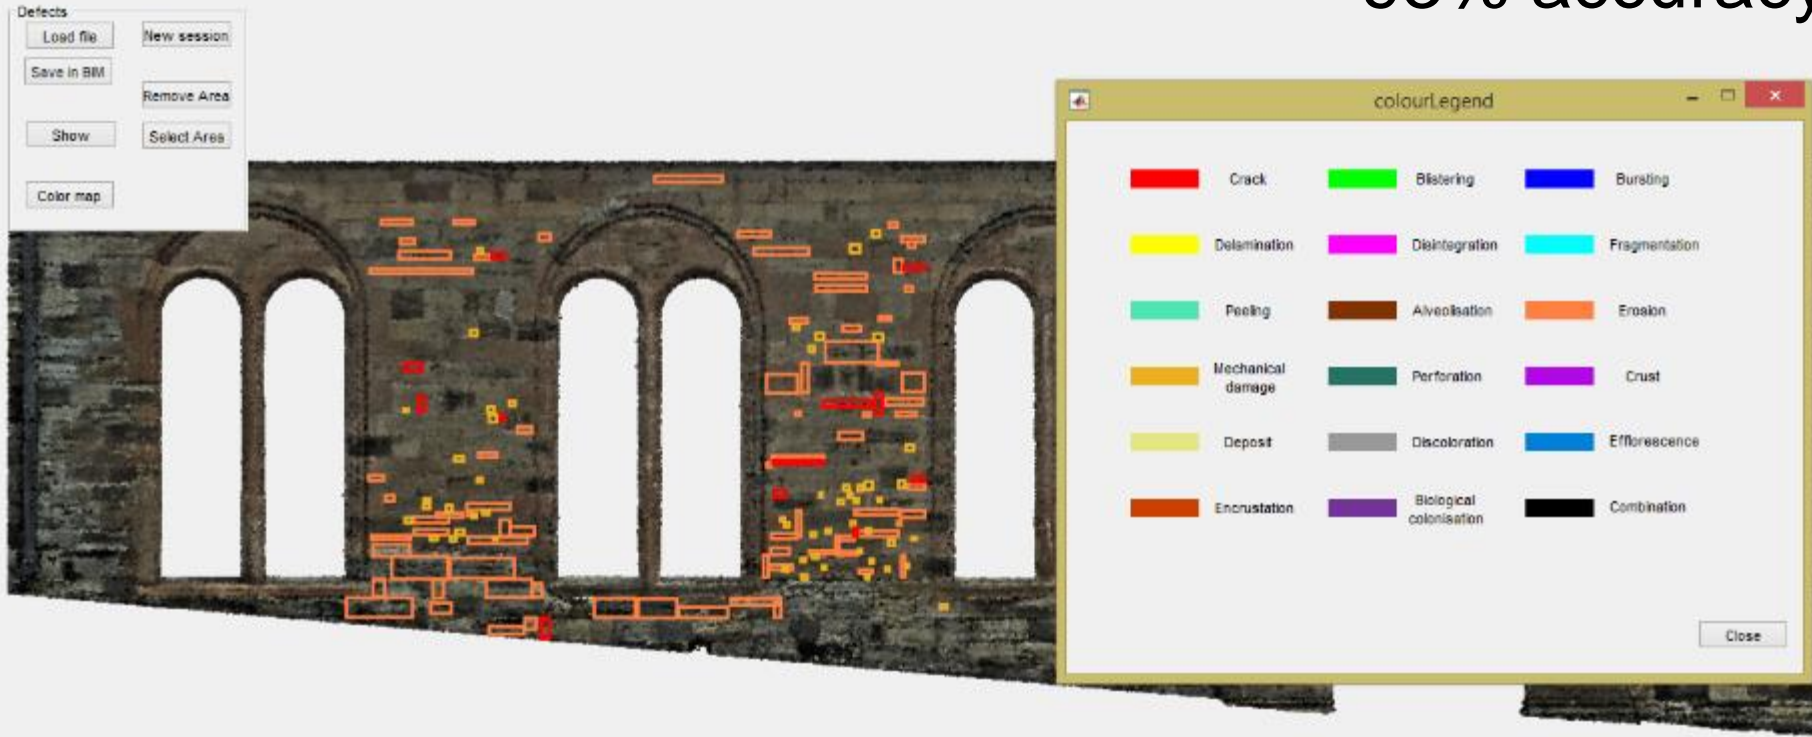
Classification / detection

93% accuracy

The screenshot displays a software interface for defect classification. The main window shows a photograph of a stone wall with several arched openings. Numerous small, colored rectangular markers are overlaid on the wall, indicating detected defects. A control panel on the left contains buttons for 'Load file', 'New session', 'Save in BIM', 'Remove Area', 'Show', 'Select Area', and 'Color map'. A 'Global view' button is also present at the top. A 'colourLegend' window is open on the right, listing 18 defect types with corresponding color swatches:

Color	Defect Type
Red	Crack
Green	Blistering
Blue	Bursting
Yellow	Delamination
Magenta	Disintegration
Cyan	Fragmentation
Light Green	Peeling
Brown	Alveolisation
Orange	Erosion
Gold	Mechanical damage
Dark Green	Perforation
Purple	Crust
Light Yellow	Deposit
Grey	Discoloration
Light Blue	Efflorescence
Dark Orange	Encrustation
Dark Purple	Biological colonisation
Black	Combination

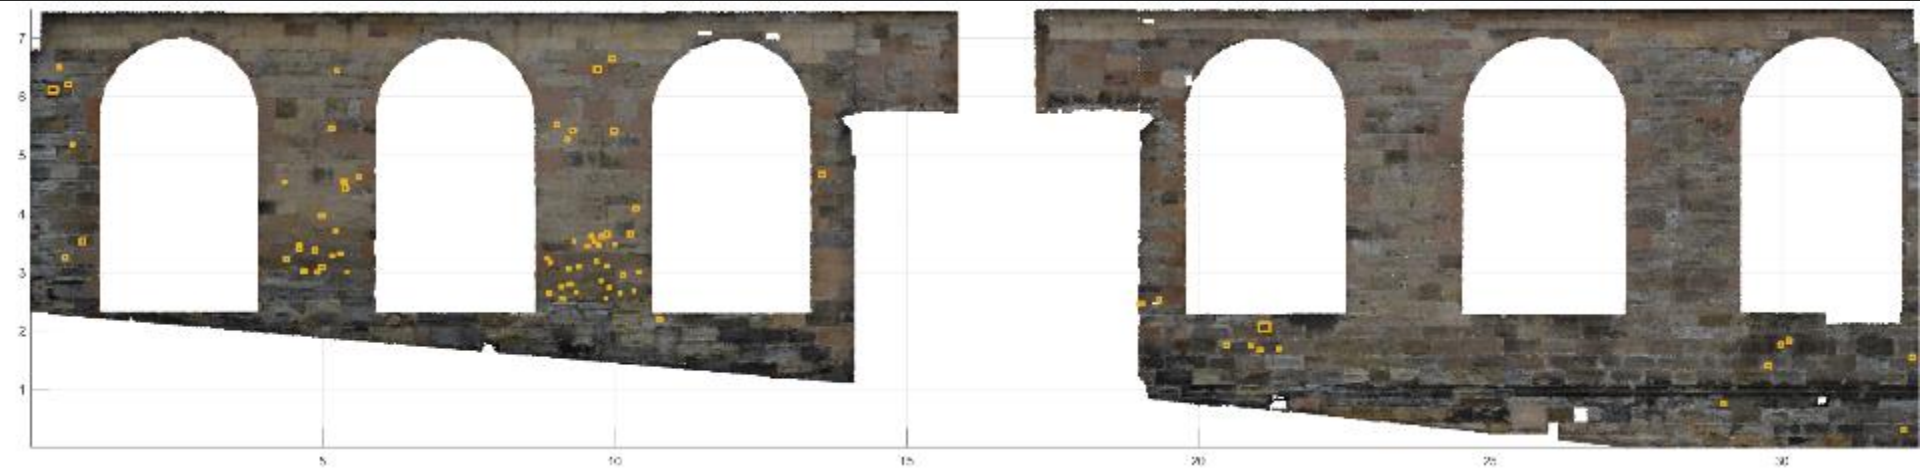
Detection / Classification

Mechanical defects

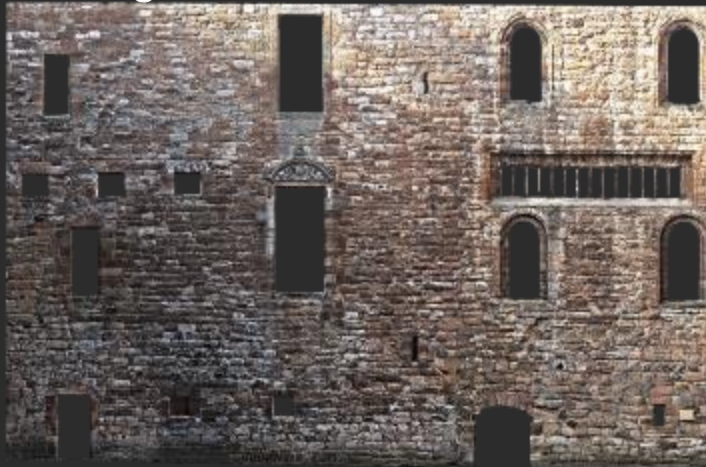
Linlithgow Palace

- Algorithms developed to evaluate various features / parameters
- Determination of change in materials or construction techniques fundamental to understanding phasing and attaching cultural significance
- Important tool for architectural analysis
